WISCONSIN TEST FACILITY
GROUND TERMINAL CORROSION STUDY

Michael Genge Edwin Wolkoff Paul Bergschneider

April 1978

U. S. Naval Electronic Systems Command Washington, D. C.

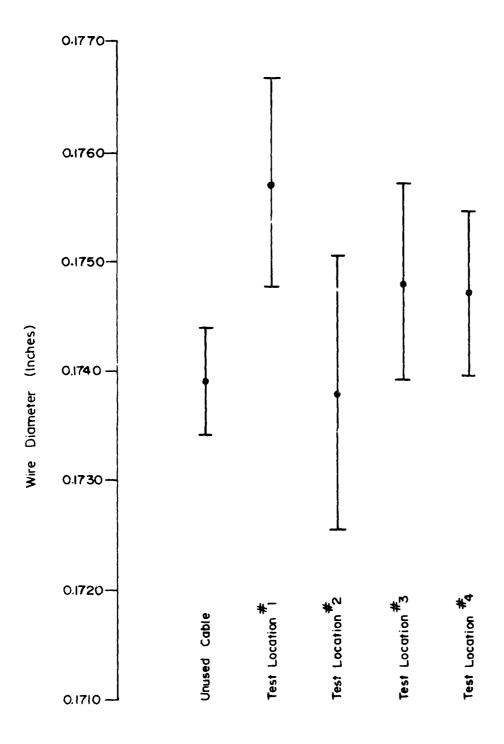
This comparison is shown graphically in Figure 4, which presents both the mean and standard deivation for the ground cable strand diameters at each of the test points and for the control sample. These results indicate that the mean strand diameter of the cable at three of the four test points was slightly greater than that of the control sample.

Fig. 4 MEAN AND STANDARD DEVIATION OF GROUND CABLE SAMPLE DIAMETERS

At the 99% level of confidence, the t-test shows the difference in mean diameter between Test and Control samples to be statistically significant only at Test Location 1. At the other locations, the sample mean diameters are not different from that of the control sample by a significant amount, according to this statistical test.
